WAUBEEKA LAKE DAM

CT 00065

PHASE I INSPECTION REPORT

JULY 1981

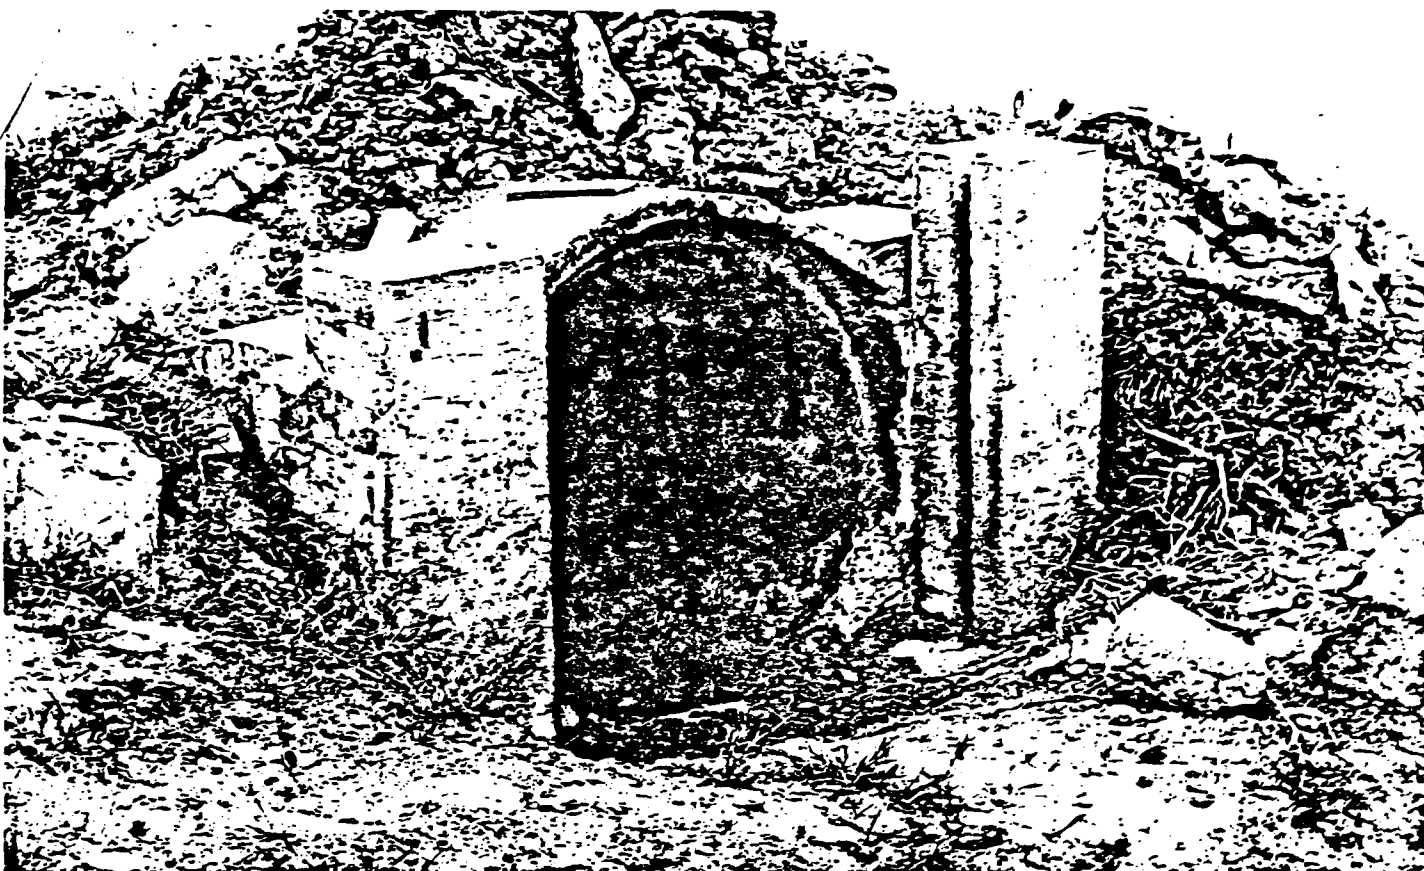
Photo #12

This is close-up of headwall  
recently constructed at inlet end  
at 36" down from Lake. See photo #6,  
made 3/3/66, for original condition here..

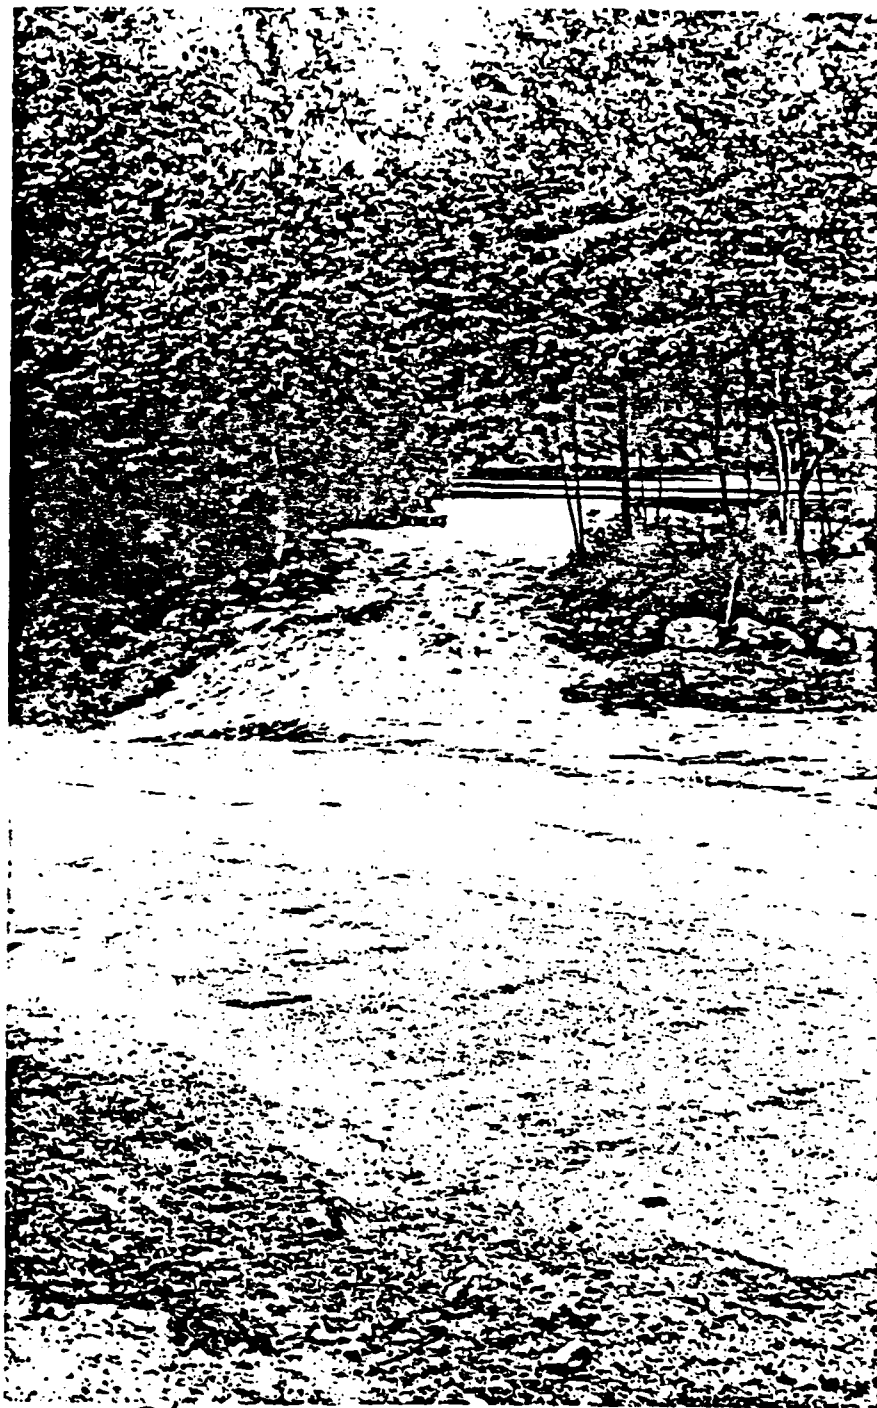
*Photo #14*

This photo shows some  
repaire to E. side dike as  
that shown in #13. Looking  
from road, over dike, Lake  
background.

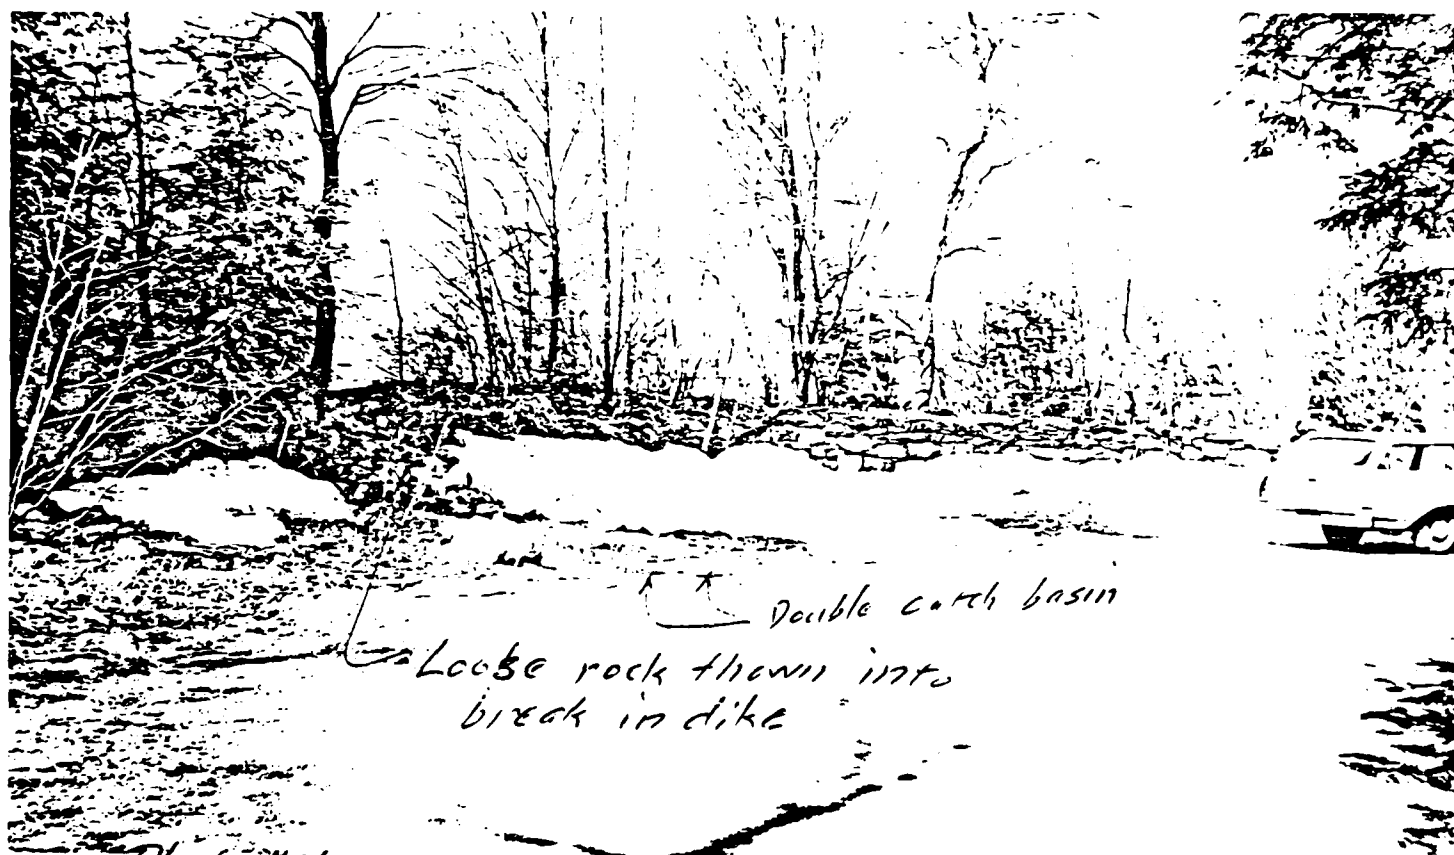
Photo #11

Double catch basin  
Loose rock thrown into  
break in dike

It is recommended that a head wall be constructed at the intake end of the 36"  $\phi$  pipe culvert on the west side. On the east side the break in the dike should be repaired with properly compacted earth fill and, where required, raised so that there will be a freeboard of at least 2' for it's entire length. Also, some stone rip-rap should be placed along the water side of the dike to prevent any erosion in case of even slight wave action.

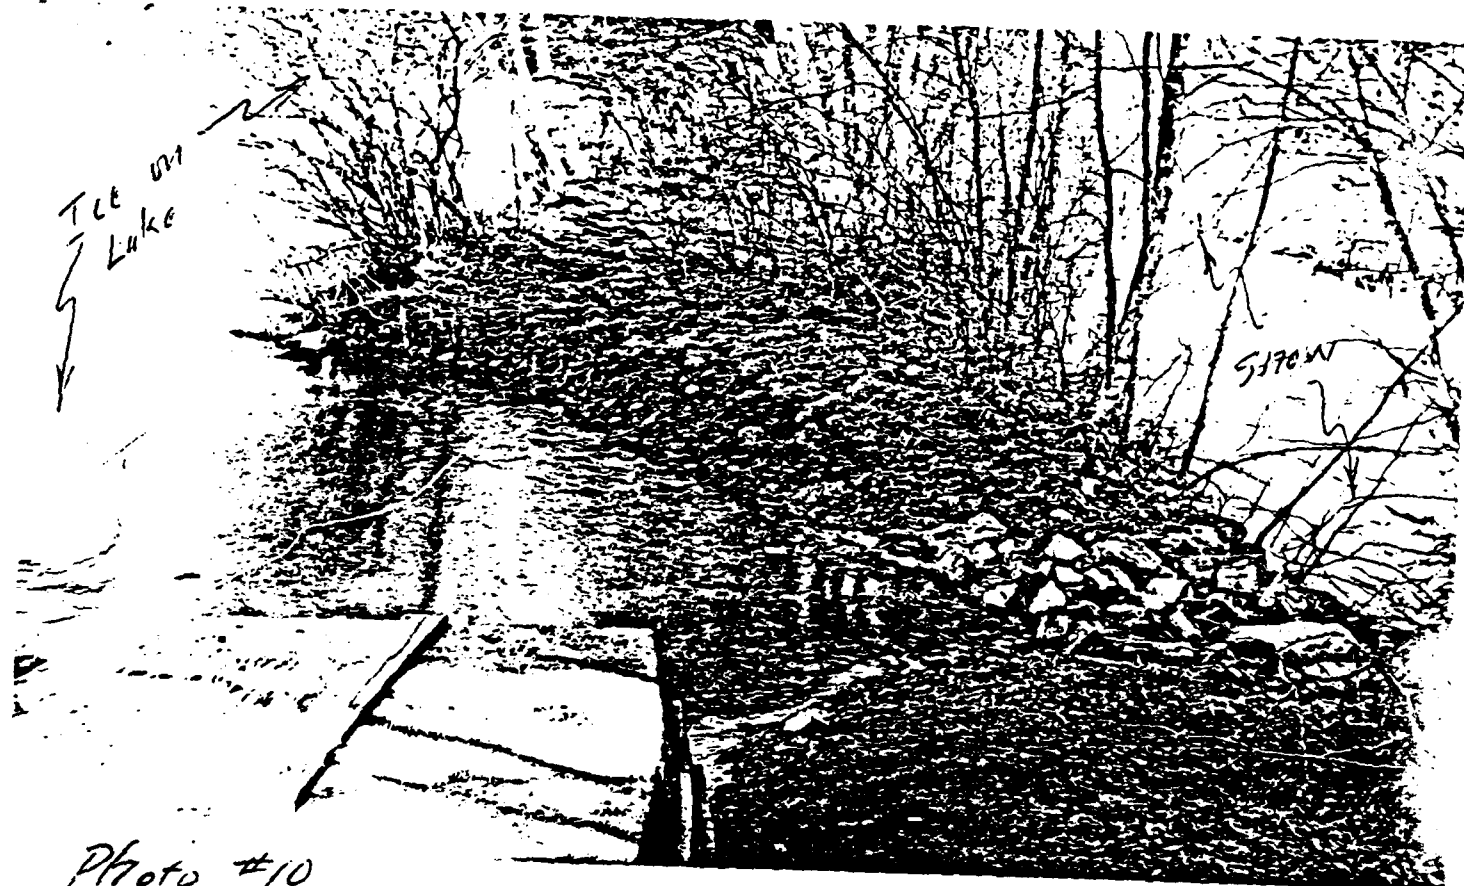
Photo #10

Break in dike on E. shore  
of Lake - note loose stone  
thrown into break.

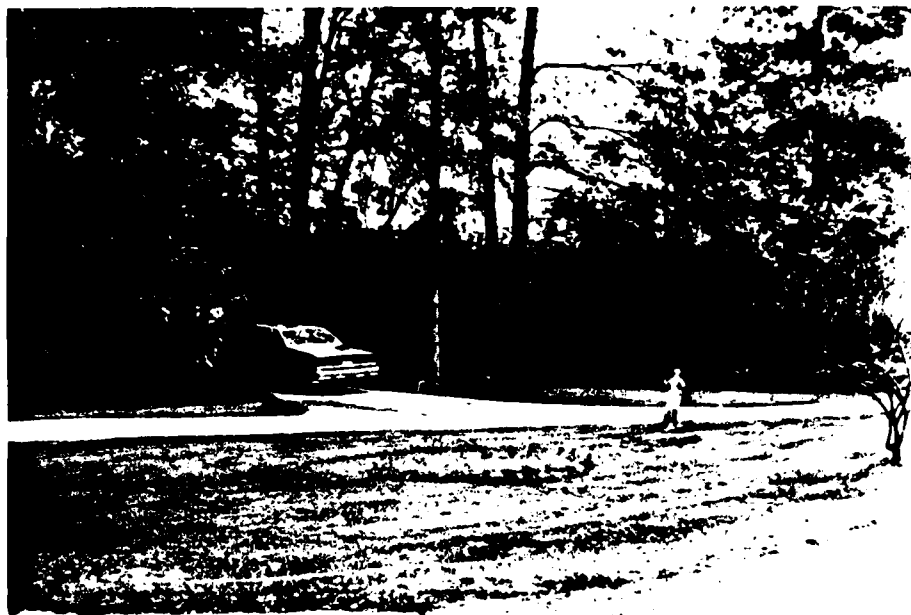
Photo 1 Downstream face and right abutment of dam on west side of Waubeeka Lake. First floor of home in impact area is defined by the deck, left.

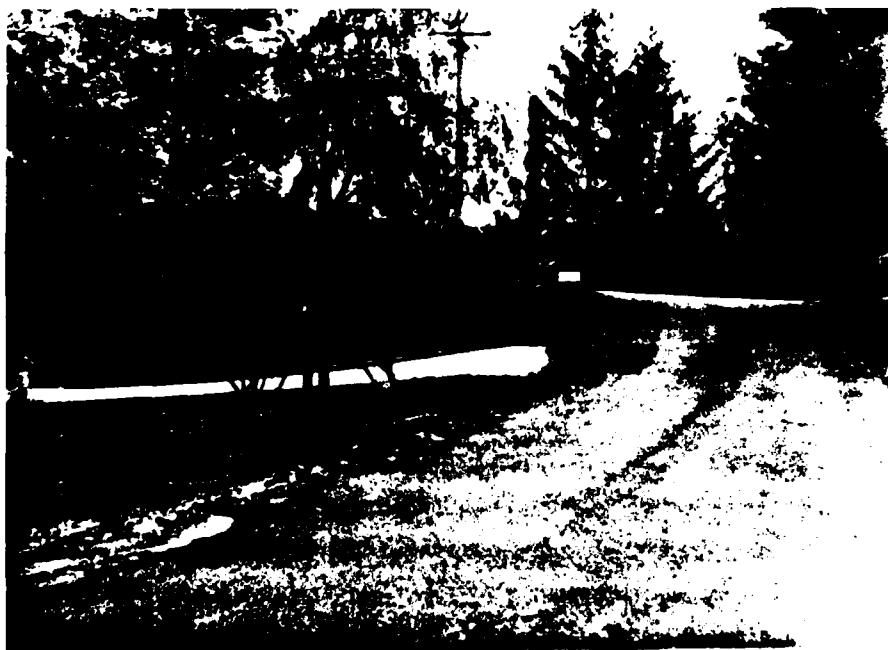
Photo 2 Downstream face of dam and Alan Road (West Dike).

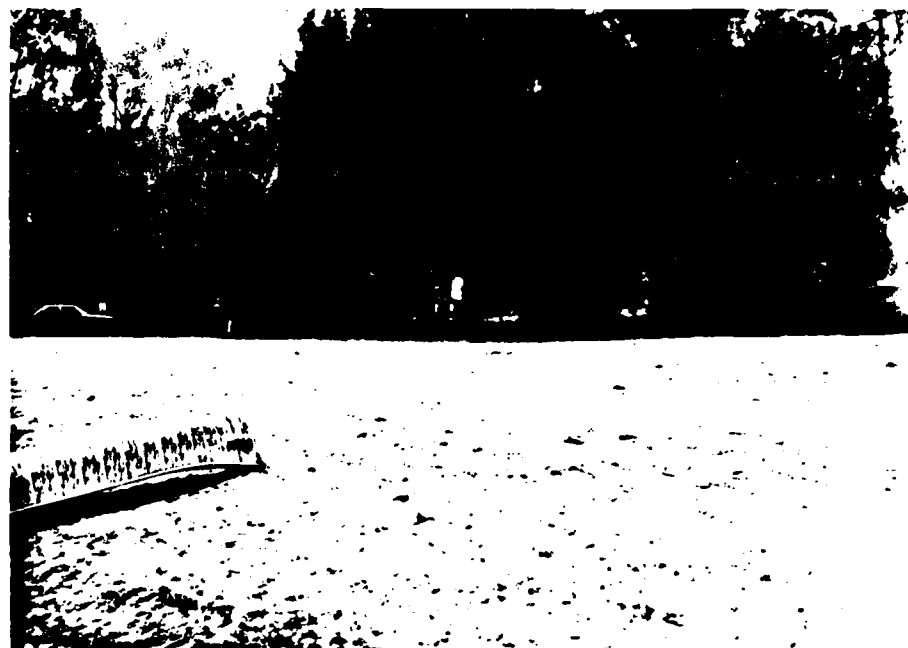
Photo 3 Upstream face of dam - Waubeeka Lake Beach (West Dike).

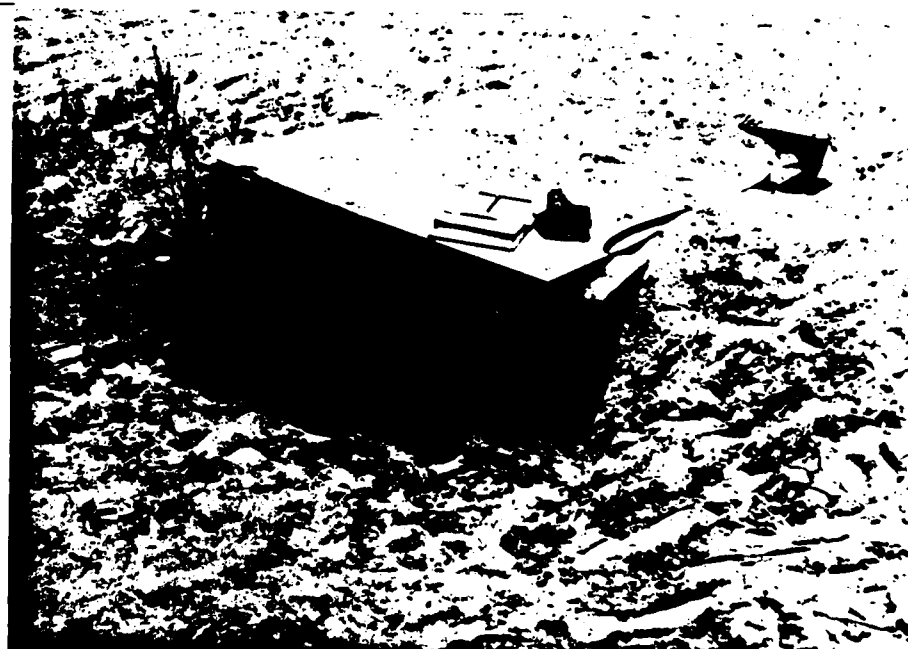
Photo 4 Intake of 3-foot diameter concrete conduit at dam (West Dike).
